AIN 024-16A

ADVISORY/RESTRICTION REGARDING HARDENED DOWNBORE CANNON RESIDUE
WHEN FIRING 155MM HOWITZERS WITH CHARGE, PROPELLING, 155MM:
M203A1 (DODAC 1320-D532) AND M232A1 (DODAC 1320-DA13)

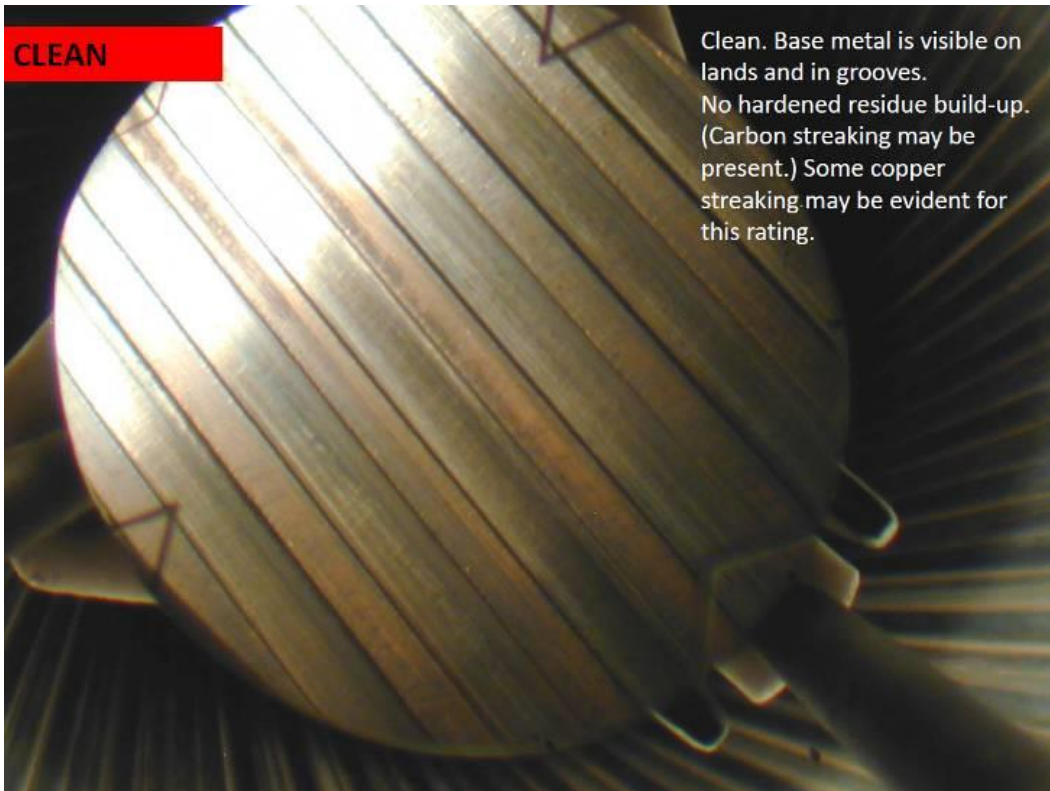
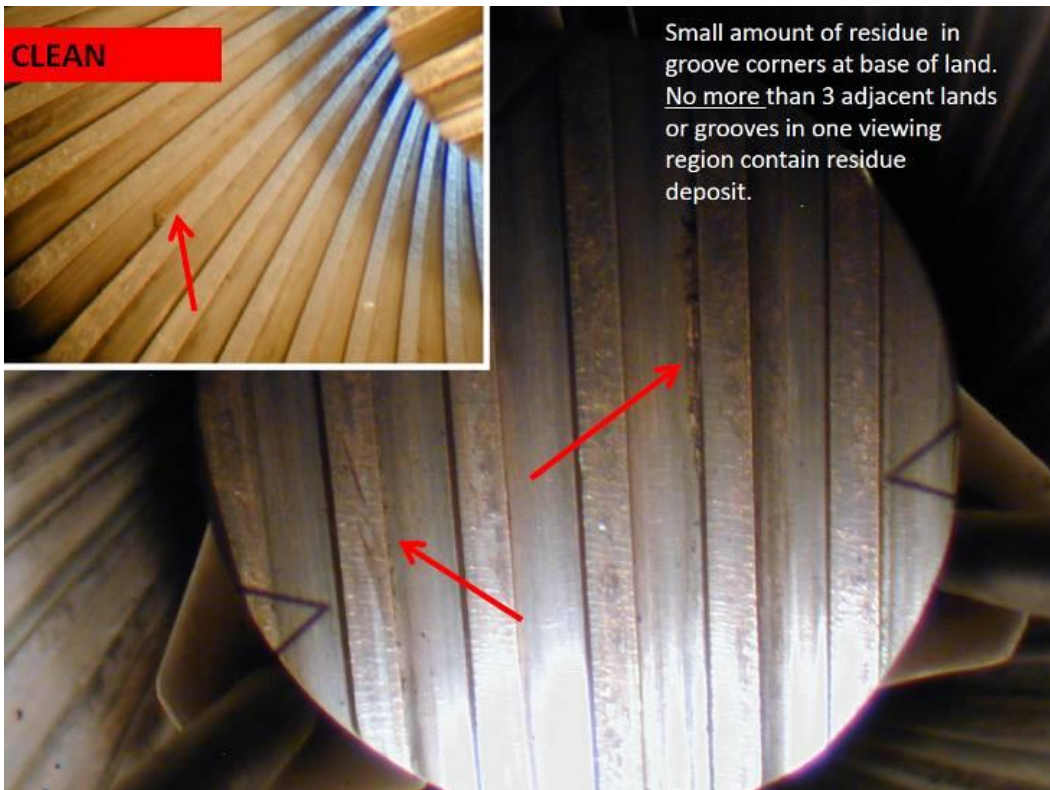
CLEAN PHOTO EXAMPLES:

CLEAN: BASE METAL IS VISIBLE ON ALL LANDS AND GROOVES.
CARBON OR COPPER STREAKING, STAINS OR DISCOLORATION MAY BE
PRESENT. SMALL UNIDENTIFIED TRACES OF GRAY MATERIAL MIGHT BE
PRESENT.

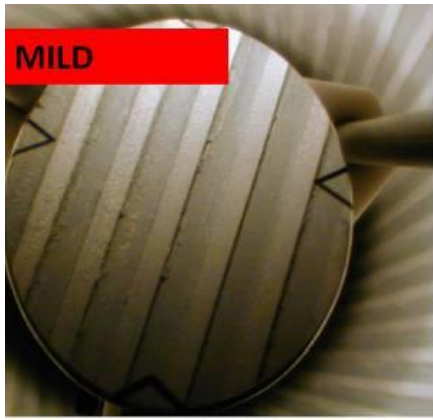
MILD PHOTO EXAMPLES:

Small amount of residue in groove corners at base of land.

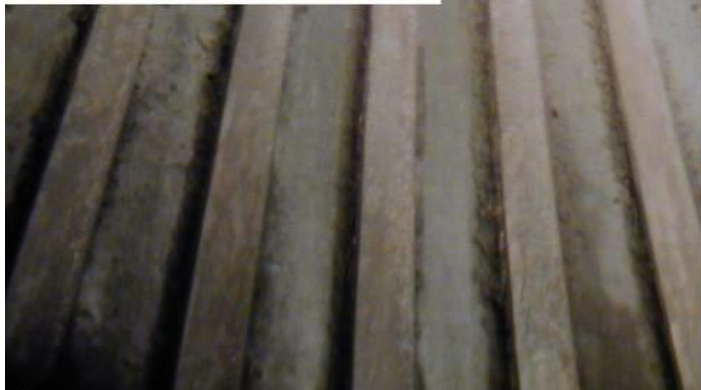
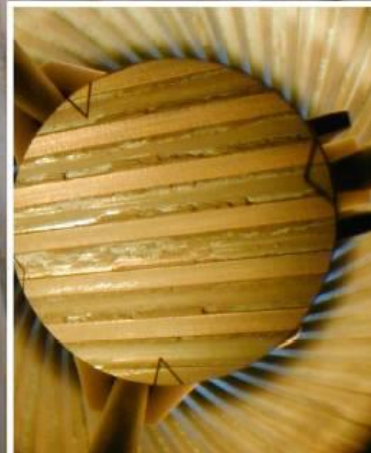
More than 3 adjacent lands in one viewing region contain residue deposit. Cannon Tube base metal is still visible.

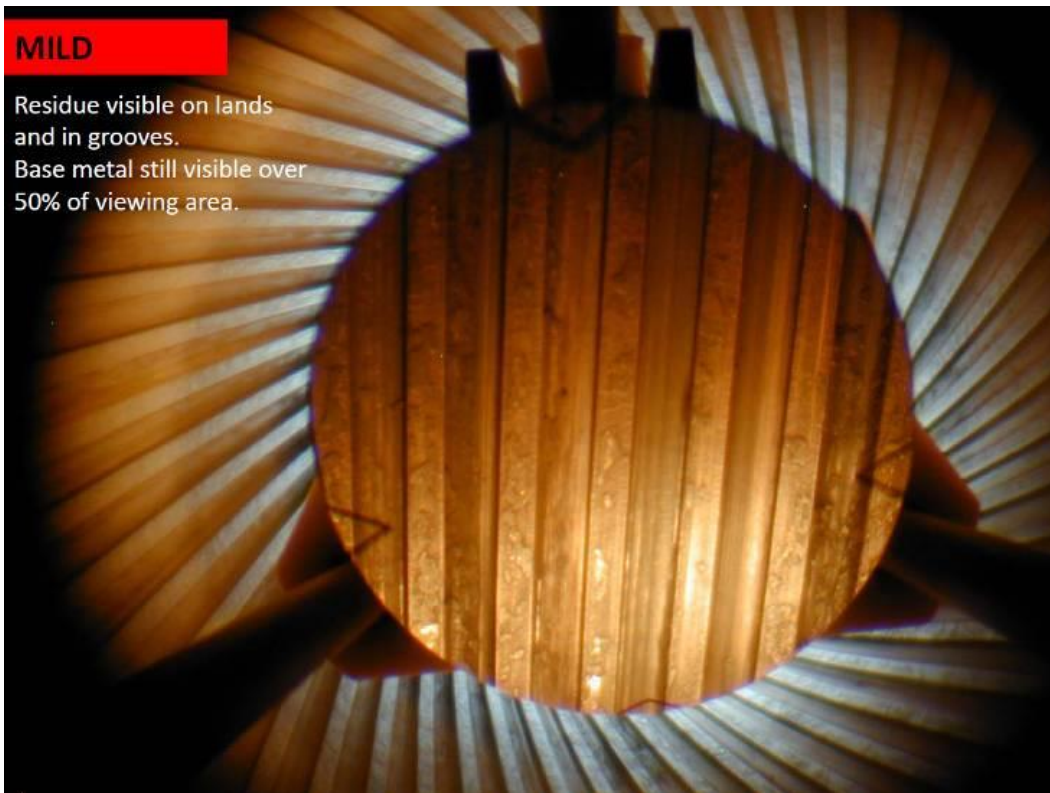
MILD

Residue visible on lands and in grooves.
Base metal still visible over 50% of viewing area.

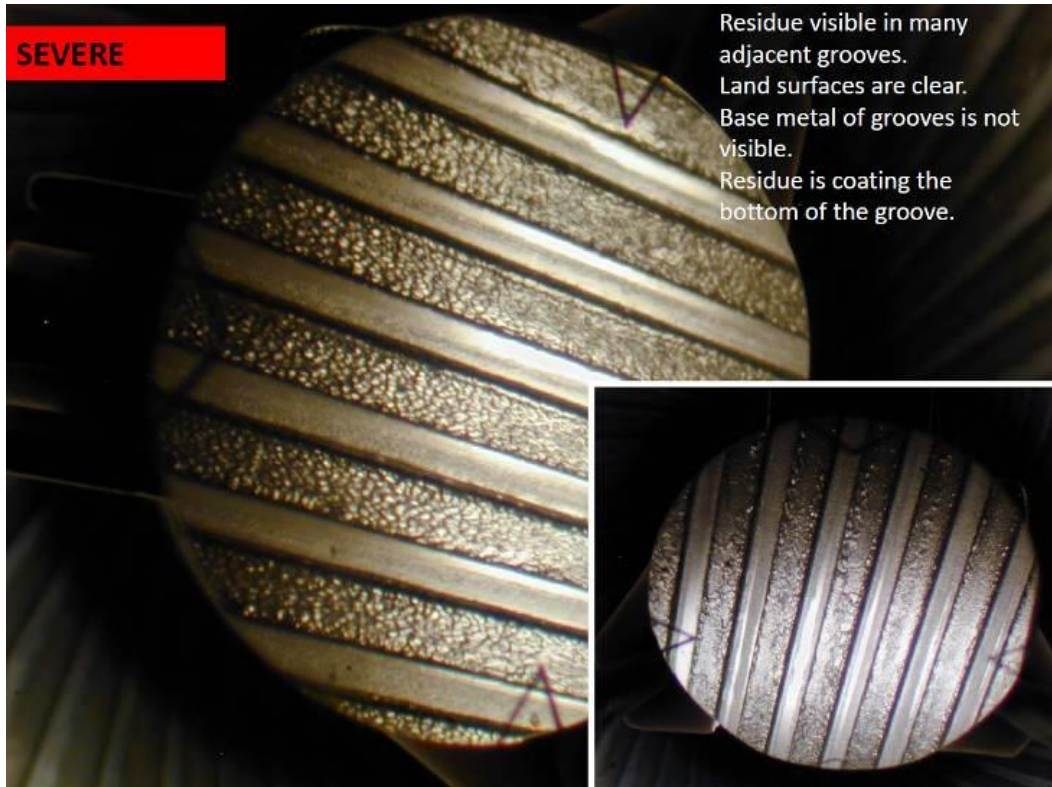
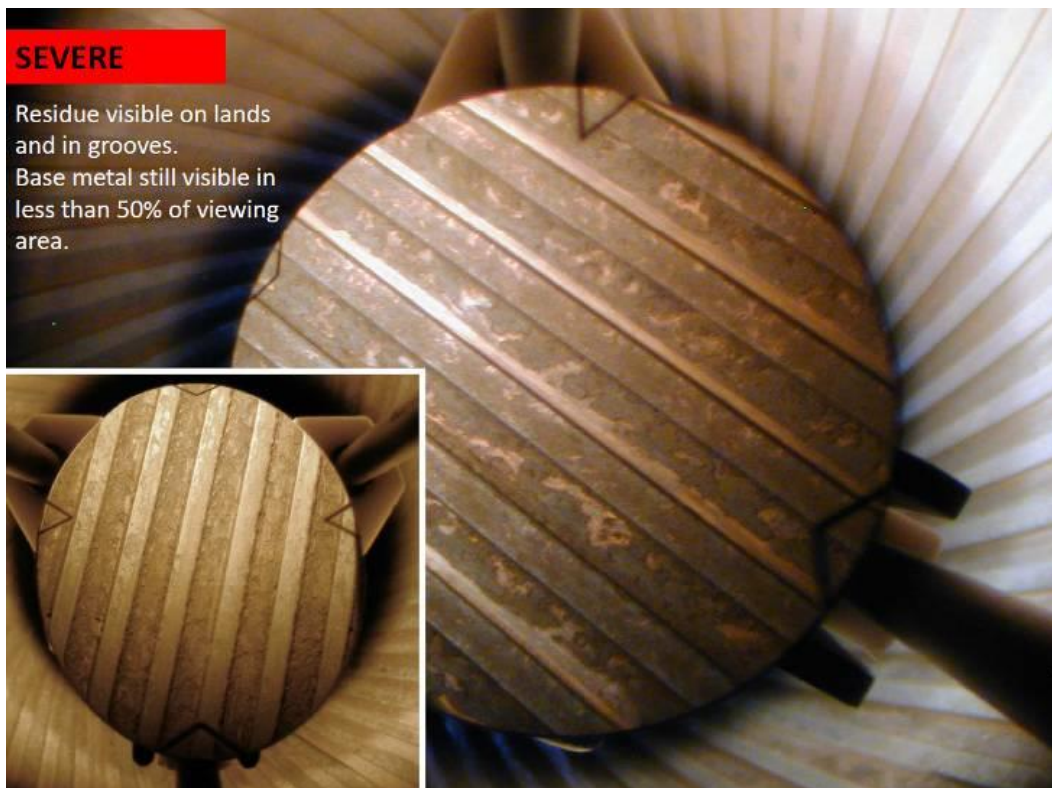
SEVERE PHOTO EXAMPLES:

SEVERE: LESS THAN 50% OF THE CANNON TUBE BASE METAL IS
VISIBLE IN ANY BORESCOPE VIEWING AREA. RESIDUE MAY BE COATING
BOTTOMS OF GROOVES OR TOPS OF LANDS. COPPER MIGHT BE MIXED WITH
THE GRAY RESIDUE.

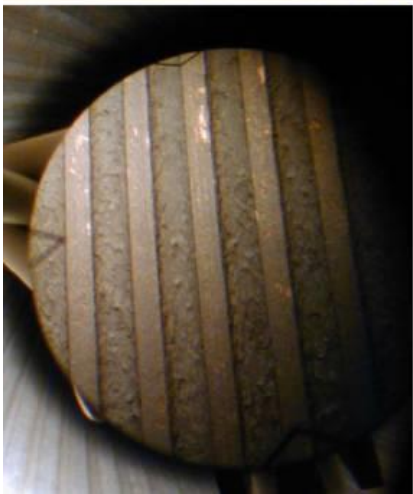
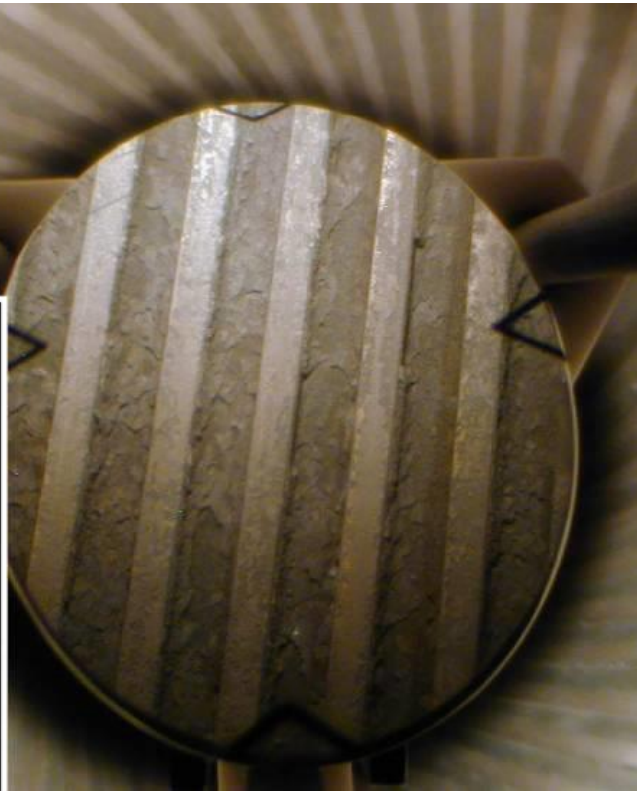
SEVERE

Residue and/or copper visible
on lands and in grooves.
Base metal visible not visible.
Proper serviceability inspection
is being masked by the residue deposit.

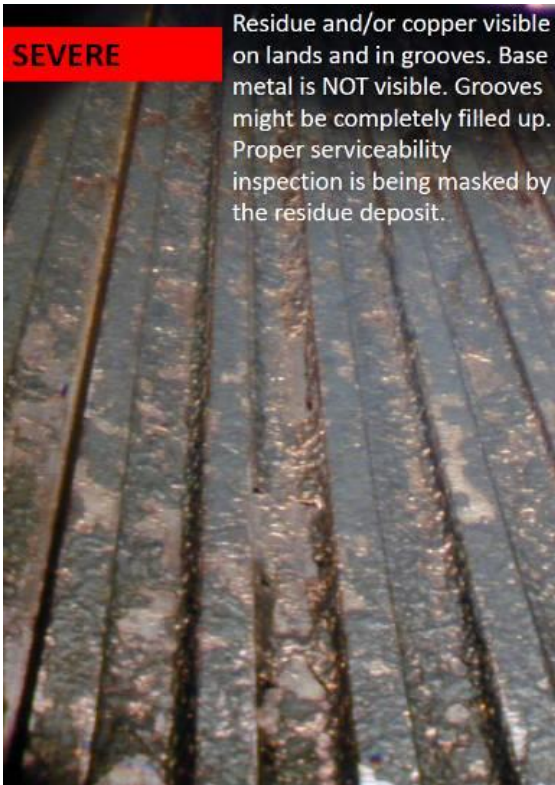
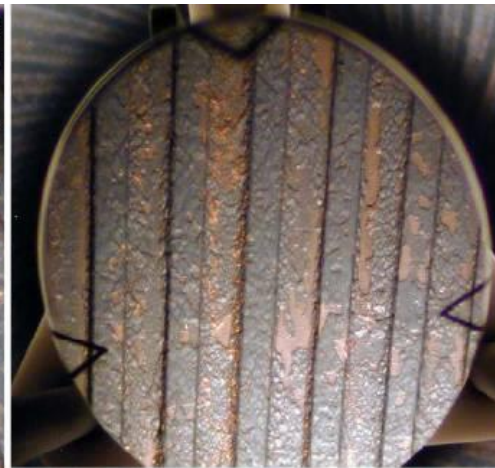
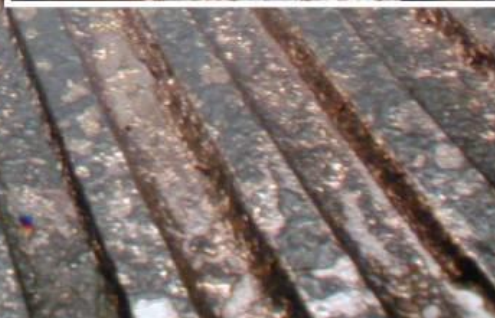
SEVERE

Residue and/or copper visible
on lands and in grooves. Base
metal is NOT visible. Grooves
might be completely filled up.
Proper serviceability
inspection is being masked by
the residue deposit.
